Ultrasonography of the rumen of dairy cows

Braun, Ueli ; Schweizer, A ; Trösch, Luzia Maria

RESEARCH ARTICLE

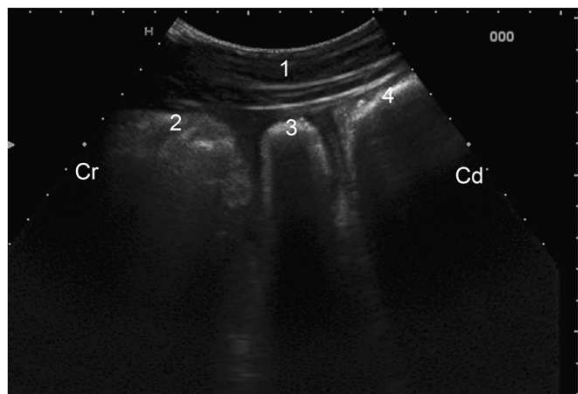
Figure 1 Ultrasonogram of the anterior dorsal blind sac.

Ultrasonogram of the anterior dorsal blind sac of the rumen of a six-year-old Simmental cow viewed from the sternal region using a 5.0-MHz convex transducer. 1 Ventral abdominal wall, 2 Reticulum, 3 Anterior dorsal blind sac of the rumen, 4 Anterior ventral blind sac of the rumen, Cr Cranial, Cd Caudal.

The anterior dorsal blind sac of the rumen was visible between the reticulum and the anterior ventral blind sac of the rumen on the left side in all cows and was always adjacent to the abdominal wall (Figure 1). It was imaged in 22 cows (49%) at the 9th intercostal space and in 23 cows (51%) at the 10th intercostal space. The hyperechoic wall of the anterior blind sac of the rumen did not differ from the wall of the ventral sac of the rumen.

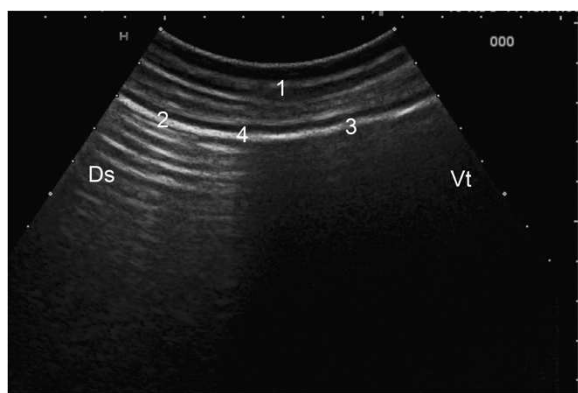
Figure 2 Ultrasonogram of the rumen. Ultrasonogram of the rumen showing the transition between the dorsal gas cap and ingesta layer viewed from the 12th intercostal space on the left side of a nine-year-old Swiss Braunvieh cow. The rumen wall appears as a hyperechoic line. Reverberation artifacts, which run parallel to the ruminal wall, reflect the gas cap and end abruptly at the transition to the fibre mat. 1 Abdominal wall, 2 Rumen wall at the level of the dorsal gas cap, 3 Rumen wall at the level of the fibre mat, 4 Transition between 2 and 3, Ds Dorsal, Vt Ventral.

craniodorsal region, where it was displaced medially by the spleen. The wall appeared hyperechoic, and the dorsal gas cap could be identified because of typical reverberation artifacts (Figure 2). Because of superimposition of the lungs, the course of the dorsal visible margin of the dorsal sac coincided with the ventral border of the lung and ran from cranioventral to caudodorsal (Figure 3, Table 1). The distance between the dorsal midline and the dorsal visible margin was largest (48.3 ± 9.24 cm) at the 9th intercostal space, decreased gradually caudally reaching a minimum (22.4 ± 3.27 cm) at the 12th intercostal space (Difference to ICS 9 $P < 0.01$) and then

The dorsal gas cap was imaged in all cows from the 12th intercostal space to the caudal flank. It was easily identified by characteristic reverberation artifacts, which disappeared abruptly at the transition to the fibre mat (Figure 2). It measured 20.5 ± 7.03 and 19.2 ± 6.33 cm at the 12th intercostal space and cranial flank, respectively, and 15.6 ± 5.35 cm at the caudal flank (Difference $P > 0.05$). The size of the dorsal gas cap changed during ruminal contractions. It was not possible to differentiate a fibre mat and a ventral fluid layer because the ingesta below the gas cap had a uniform ultrasonographic appearance.

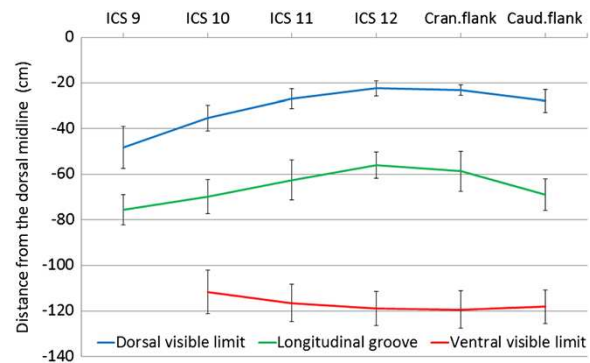
Figure 3 Visible margins of the rumen. Dorsal and ventral visible margins of the rumen and location of the left longitudinal groove relative to the dorsal midline imaged ultrasonographically from the 9th intercostal space to the caudal flank on the left in 45 cows (mean \pm standard deviation).

increased slightly toward the caudal flank (27.8 ± 5.01 cm). The left longitudinal ruminal groove formed the ventral margin of the dorsal sac of the rumen and its course was parallel to the dorsal visible margin (Figure 3). It was furthest from the dorsal midline at the 9th intercostal space (75.6 ± 6.52 cm), became gradually closer to the dorsal midline toward the 12th intercostal space (56.0 ± 5.88 cm) (Difference to ICS 9 $P < 0.01$) and then deviated ventrally in the flank (69.0 ± 6.84 cm).

of the rumen extended across the ventral midline into the right hemiabdomen. The distance between the dorsal midline and the ventral margin of the ventral sac of the rumen varied little (Figure 3, Table 1). At all examination sites, the visible height of the ventral sac of the rumen was greater than the visible height of the dorsal sac (Figure 4); it was largest at the 12th intercostal space (62.6 ± 9.53 cm) and smallest at the 10th intercostal space (46.0 ± 8.65 cm; Table 1) (Difference to ICS 12 $P > 0.05$). The mean distance between the wall of the ventral sac and the abdominal wall varied from 4.6 cm to 6.1 cm. Other structures such as the abomasum, small intestines and omentum were occasionally seen ventrally between the abdominal wall and rumen. The mean thickness of the wall of the ventral sac of the rumen was 0.3 cm.

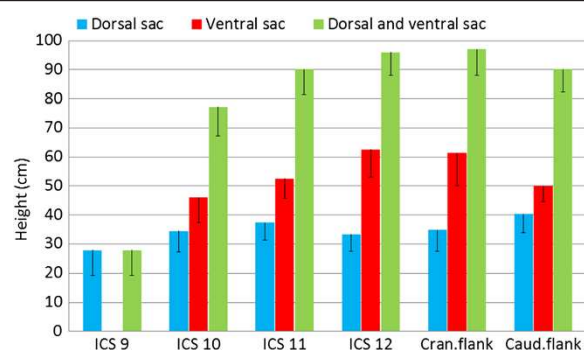
Figure 4 Height of the rumen sacs. Height of the visible dorsal and ventral rumen sacs and the entire rumen imaged ultrasonographically from the 9th intercostal space to the caudal flank on the left in 45 cows (mean \pm standard deviation).

The visible height of the dorsal sac of the rumen was largest in the caudal flank (40.3 ± 6.33 cm; Figure 4), decreased cranially because of superimposition of the lung and measured 27.9 ± 8.74 cm at the 9th intercostal space (Difference to the caudal flank $P < 0.05$). In the left flank, the dorsal sac of the rumen was adjacent to the abdominal wall (distance 1.1 ± 1.38 cm). Cranially the distance between the abdominal wall and dorsal sac of the rumen increased gradually; it measured 10.3 ± 1.66 cm at the 9th intercostal space because of interposition of the spleen, which increases in thickness cranially. The mean thickness of the wall of the dorsal sac of the rumen was 0.3 cm.

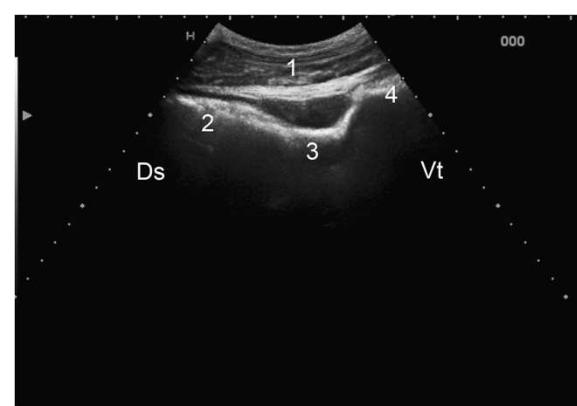
Figure 5 Ultrasonogram of the longitudinal groove.

Ultrasonogram of the rumen of a three-year-old Holstein Friesian cow viewed at the level of the longitudinal groove at the 12th intercostal space. 1 Abdominal wall, 2 Dorsal sac of rumen, 3 Longitudinal groove, 4 Ventral sac of rumen, Ds Dorsal, Vt Ventral.

The left longitudinal ruminal groove separates the dorsal and ventral sacs of the rumen. It could be clearly identified at all examination sites because it appeared on ultrasonograms as a typical triangular notch (Figure 5), which was more distinct caudally than cranially.
